ELIMINATION OF FAILURES OF NARROW GROOVE WELD JOINTS, THOROUGH PHASE ARRAY INVESTIGATION

Fabricated structure; boom; boom foot boss; weld defect; phase array ultrasonic testing.

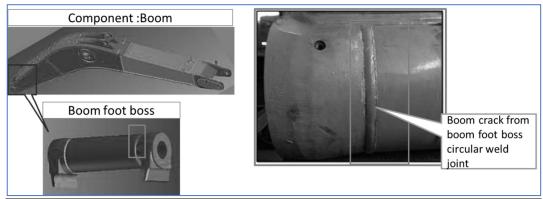
Circular butt welded joints were reported with visble cracks on the surface, as specified in Figure 3. Fauilres were reported at average hours within 2000 hours of machine operation at site. This failure hous was considered to be very pre-mature considering average operation of of machine upto 10000 hours. This failure of weld joints results in immediate breakdown of exacavtaor for customer and needs to either reapir locally of replace the boom structure. Both this actions were considered to be very costly and time consuming for both manufactururs and customers.

Figure 3: Failure detail- crack in boom foot boss circular joint

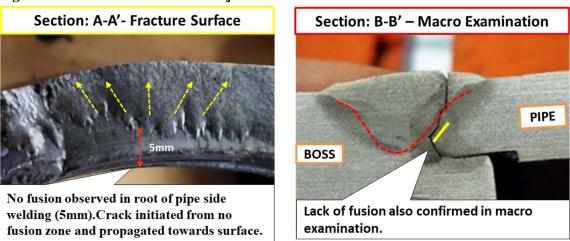
Once failure part was received from field, quality team had initiated failure cause analysis. Metallurgical and mechanical tests for the failed components were found to be accepted. The defect details of failure analysis observation are stated below in Figure 4 a. and 4 b. As per macro sample examination lack of fusion was observed at the root of the section towards joining end of central tub of boom foot boss. The fracture surface depicted that the crack initiated from the lack of fusion zone at root of weld section and propagated towards the surface

of weld joint. No fusion found in root run welding: length- 50mm height- 5mm. as specified in Figure 4 b.

Figure 4 b.: details of circular weld joint crack, defect location at root of weld section 1.5 Fishbone analysis for cause of lack of fusion

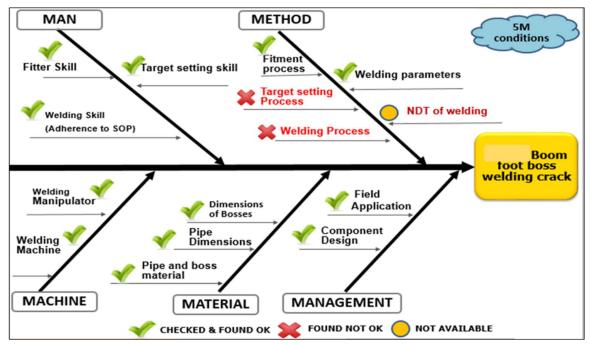
As a standard practice and tool for root cause analysis Fish bone or Ishikawa (Liliana 2016) has be deployed to identify the actual cause of failure and specified in Figure 5. In this work gap of nondestructive testing (NDT) has been taken for improvement.

Figure 5: Fish bone or Ishikawa for lack of fusion

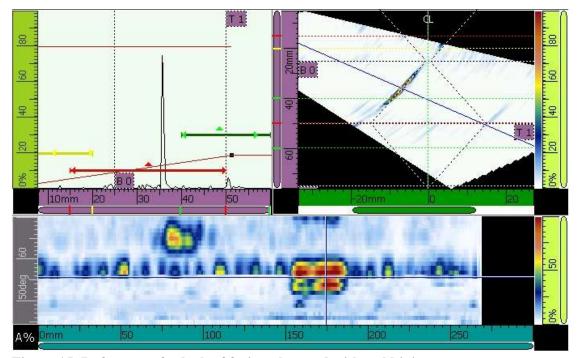
Once able to identify defects, defects were repaired, and rechecking was performed for defective joint. This improvement had resulted complete elimination of defects and failures of stated circular boom foot joint and hence eliminated customer's machine downtime. Defect maps observed using phase array ultrasonic testing are shown in Figure 15 & Figure 16 for lack of fusion and porosity defect respectively, within the weld joints.

Figure 15: Defect map for lack of fusion observed with weld joint

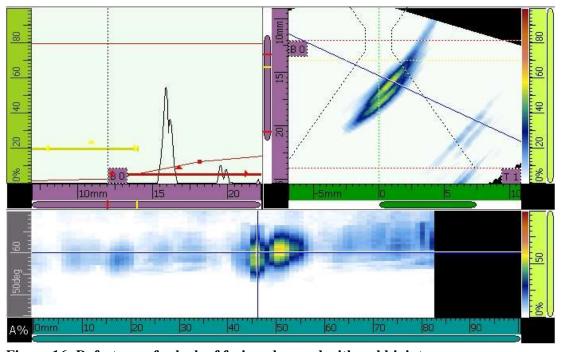
Figure 16: Defect map for lack of fusion observed with weld joint
