ELIMINATION OF FAILURES OF NARROW GROOVE WELD JOINTS, THOROUGH PHASE ARRAY INVESTIGATION

Fabricated structure; boom; boom foot boss; weld defect; phase array ultrasonic testing.

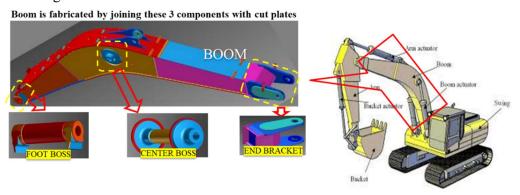
Figure 1: Details of excavator boom 1.2 Problem description

Basic details of excavator boom are specified in Figure 1. This boom is made of combination of various cut plate sections and had 3 major minting section called boom foot boss, center hub and end bracket. Boom for boss and center hub were made of combination of forged section at both ends and tube at middle portion, which were combine using welding at circular weld joints between forged end sections with middle tube.

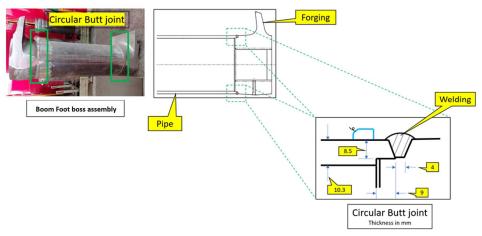
Figure 2. Boom foot boss joint configuration

Joint Configuration: Boom foot boss is sub assemble of cylindrical hollow tube at center and machine forging sections at both ends. These 3 parts, 2 forgings and 1 tube were joined together using a welded circular butt joint as specified in Figure 2.

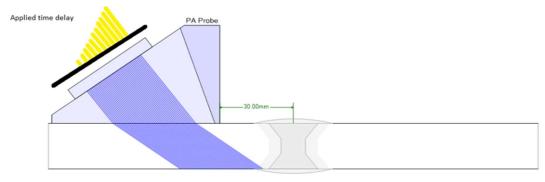
Figure 7: Wave front

For the wavefront to be steered at a particular angle, there should be a constant delay in pulsing between each successive element in the probe. This wavefront generated as specified in Figure 7, due to this delay in pulsing is like ultrasonic beam produced by a conventional ultrasonic angled probe(Sudhir, n.d.).

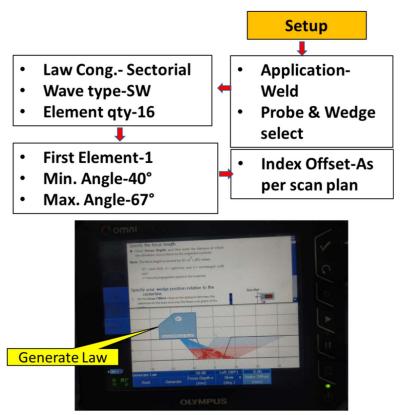
Figure 10: Setup in instrument wizard

Details of setup and sequence specified in Figure 9 & Figure 10. The machine setup in instrument wizard has two steps. First step is to define part and weld, as specified in Figure 9 Second stage is setup in instrument wizard for starting the process of scan as specified in Figure 10.

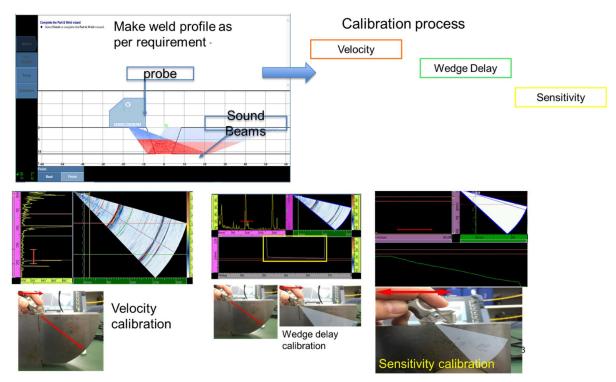
Figure 12: Details of calibration

This is important so the error free judgement could be made, and exact location, size and depth of defect can be identified. Calibration methodology is complex, and sequence of operation as specified in Figure 12, consisting of three steps viz. Step A called as velocity calibration, Step B called as wedge delay calibration & Step C called as sensitivity calibration. In Step A of velocity calibration, sound speed calibration was performed using the Radius part of the STB-A1 test piece (Yamada, Yano, and Udagawa 2004). 100 unit was selected as the reflection echo from R100 in "Radius 1", similarly 200 for R100's repetitive reflection echo in radius 2. Setting of the radius 1 and radius 2 was done. Angle axis was selected for sound velocity calibration

If the wedge delay has been calibrated correctly, approval for finishing the wedge delay calibration is given. In Step C, sensitivity calibration was performed using $\varphi 1.5$ mm SDH of STB-A1 specimen (Yamada, Yano, and Udagawa 2004), "measurement range" was adjusted so that a $\varphi 1.5$ mm SDH echo can be confirmed at 40 ° and 70 ° when scanning back and forth and Reference Amplitude" is set at 80% with a tolerance of +/-5% amplitude. range of the angle axis to be calibrated in "Angle end position is selected as 75, Gate A (red gate) surrounds the reflection echo of $\varphi 1.5$ mm SDH adjusted "Start Position" and "Width" with 10 threshold. The probe was scanned back and forth so that the reflected echo of $\varphi 1.5$ mm SDH captures the peak at all angles, and the peak echo height information was recorded at each angle component. The peak echo of all angle components was kept within 20% to 80%. Adjust "Gain". When all the peaks do not fit within 20% to 80% with "Gain" adjustment `` Correction gain '` was used. With all the peaks within 20% to 80%, correction gain setting was done. To check whether the calibration has been performed correctly, the probe was scanned back and forth again to confirm that the peak echoes captured by all angle components were within the preset tolerance.

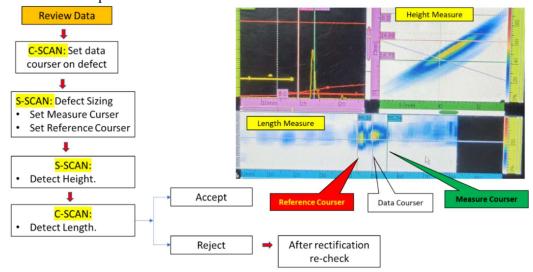
Figure 13: Details of scanning steps for defect identification

Evaluation of defect was performed in a sequence of steps as stated in Figure 13, it consists of C -S-S-C scan procedures.

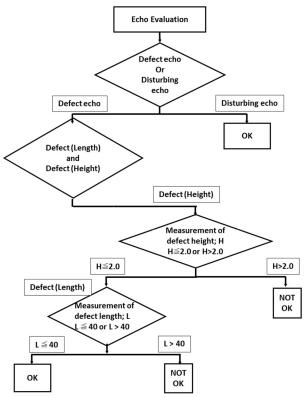
Figure 14- Defect acceptance, rejection flow chart

Defect acceptance/rejection steps was performed as per steps detailed in Figure 14.
